Bridge Views

Issue 72 _____ September/October 2013

Genesee Avenue Pedestrian Overcrossing, a Concrete Bridge with a High Degree of Curvature

Controlling Prestress Release Cracks in High Performance Concrete Bridge Girders

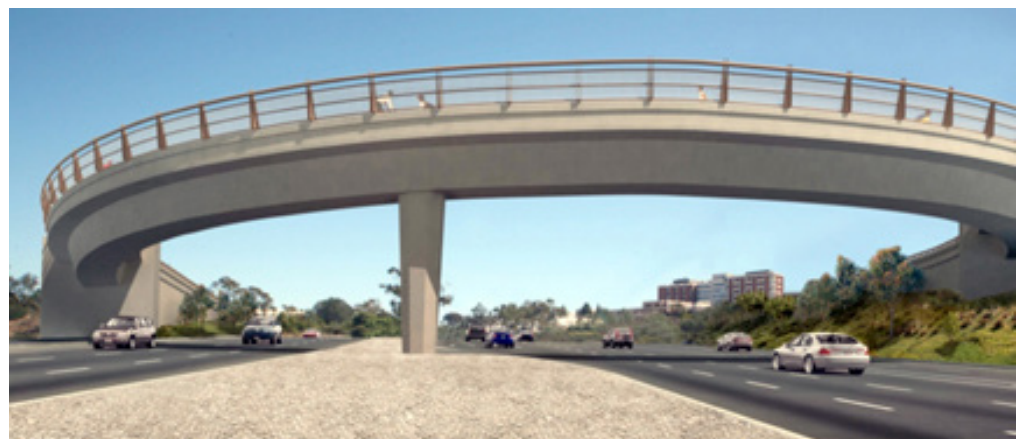
Fig. 1. Genesee Avenue Pedestrian Overcrossing (Rendering)

It is not every day that a bridge engineer gets the opportunity to design a semi-circular pedestrian bridge. Our opportunity presented itself as part of the 22-mile I-5 North Coast Corridor project located along the scenic I-5 corridor in coastal San Diego, California. The Genesee Avenue Pedestrian Overcrossing (POC) will provide a direct connection across Genesee Avenue for a new class 1 bicycle and pedestrian facility that will run parallel to I-5 on the west side. The two-span, 260-foot-long, 18-foot-wide, cast-in-place reinforced concrete box girder bridge was designed for an extreme horizontal curve (115-foot radius) as demanded by architectural and layout needs. The box girder type was selected for its high torsional rigidity. The bridge will be supported on a single-column bent and diaphragm-type abutments with deep foundations; this serves as a creative solution to handle the torsional demands imparted by the superstructure.

Aesthetics were a major consideration for this bridge being that this is the first significant project on the corridor and will be looked at to set the stage for all future segments. Close coordination with the City of San Diego, Caltrans and the San Diego Bicycle Coalition was required. The horizontal curve of the POC was ultimately chosen not only for the functional purpose of providing an uninterrupted pathway across Genesee Avenue for the benefit of the bicycle users, but also to provide a uniquely shaped signature structure for the coastal corridor. Integral colored concrete, a

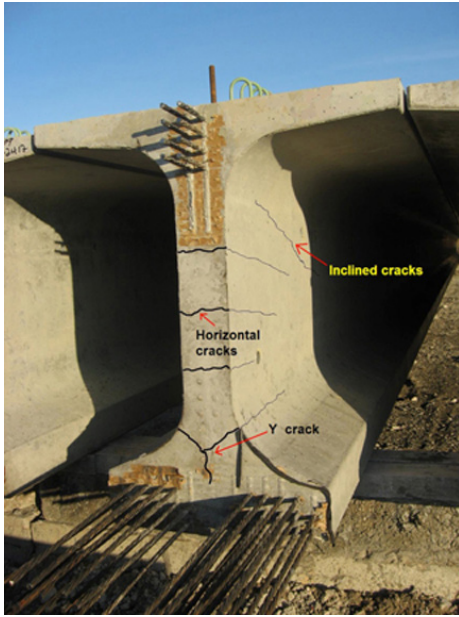
Fig. 1. An example of girder cracks

Bulb-Tees are a prime example, often with deep sections, slender webs, and large amounts of prestress. The 54-inch deep girder shown in Figure 1 exhibits three types of typical end cracks: inclined cracks that run parallel to draped strands near the top of the web, horizontal cracks

over the web depth, and bottom-flange Y cracks. The inclined cracks and horizontal web cracks may close as loads are applied to the girder and compressive end reactions develop. The Y or T shaped cracks, however, propagate into the bottom flange where strands are located and can increase in width to 0.05 inches as loads are applied.

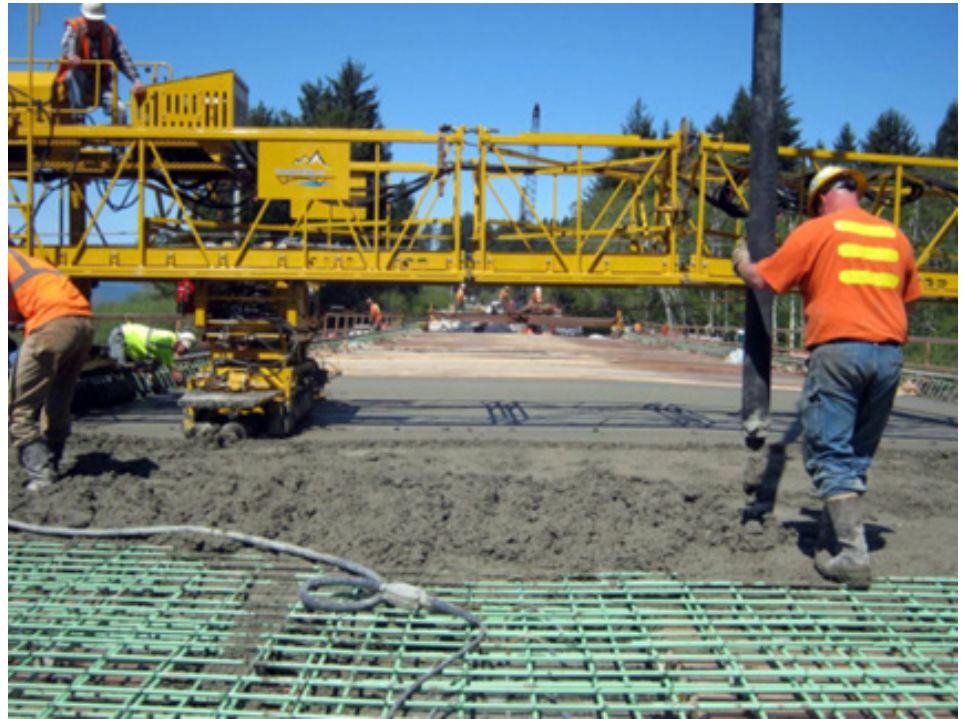
Fig. 1. Bridge deck placement and curing

WSDOT also made changes to the concrete placement and curing requirements. New requirements eliminate curing compound, instead requiring fogging to prevent moisture loss from fresh concrete. Once the finishing of the concrete is complete, pre-soaked burlap or other finishing blankets are immediately laid out on the wet deck. Soaker hoses

are placed and deck is covered with reflective sheeting as soon as the concrete achieves initial set. After the 14-day wet cure is completed, diamond grooving is used to provide longitudinal tining of the deck necessary for skid resistance. These changes to the concrete mix and finishing/curing practices have significantly reduced deck cracking as illustrated in Figures 2 and 3.

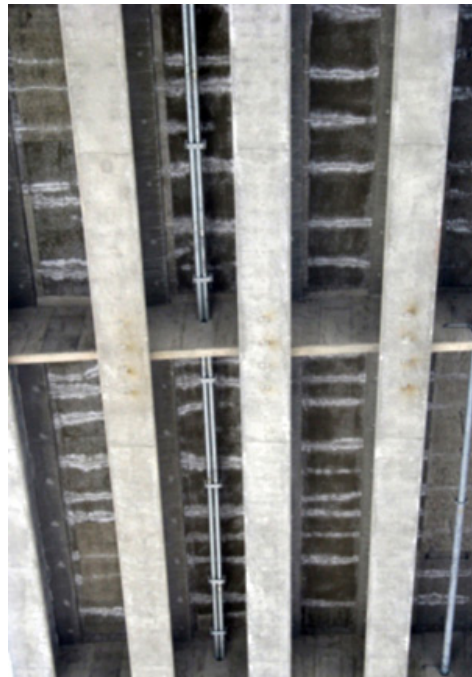
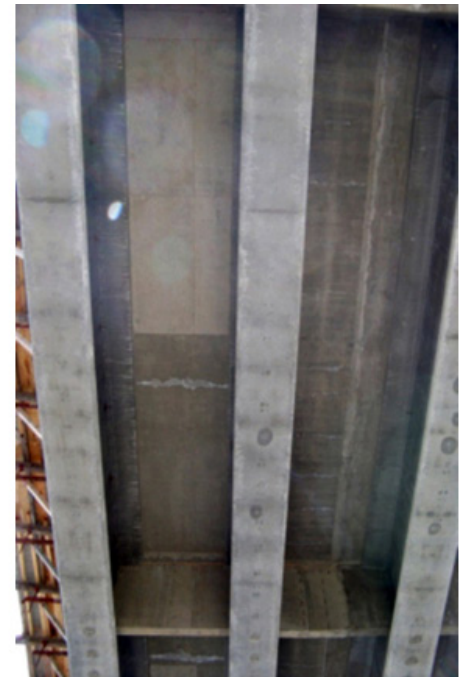
Fig. 2. (left) – View of the underside of a bridge deck constructed in 2010 with conventional bridge deck concrete. Fig. 3. (right) – View of the underside of a bridge deck constructed in 2013 using WSDOT performance-based bridge deck specifications

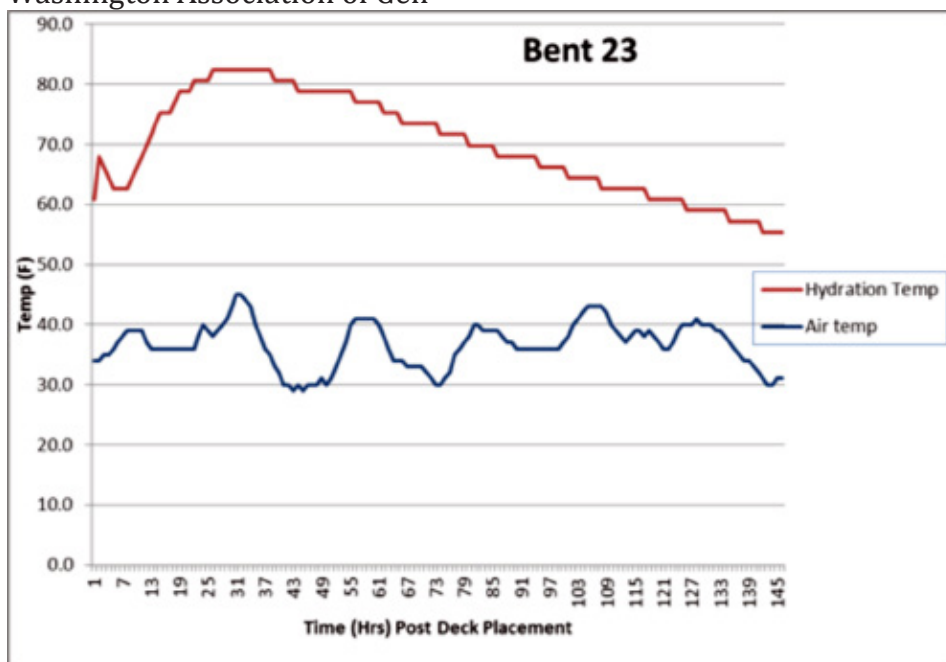
Fig. 4. Deck hydration temperature vs. ambient temperature

Although implementation of the new specifications has reduced deck shrinkage cracking, minor cracking is still evident. One factor that can significantly contribute to early transverse deck cracking is the differential between deck peak hydration temperature and ambient temperature. The strain due to this temperature differential can be as much as 300 micro-strains (Figure 4).
