# Bridge Views

Issue 74 \_\_\_\_\_ January/February 2014

## Piles with Corrosion-Free Carbon Fiber Composite Cable in Virginia

## Corrosion of Reinforcement in High Performance Concrete

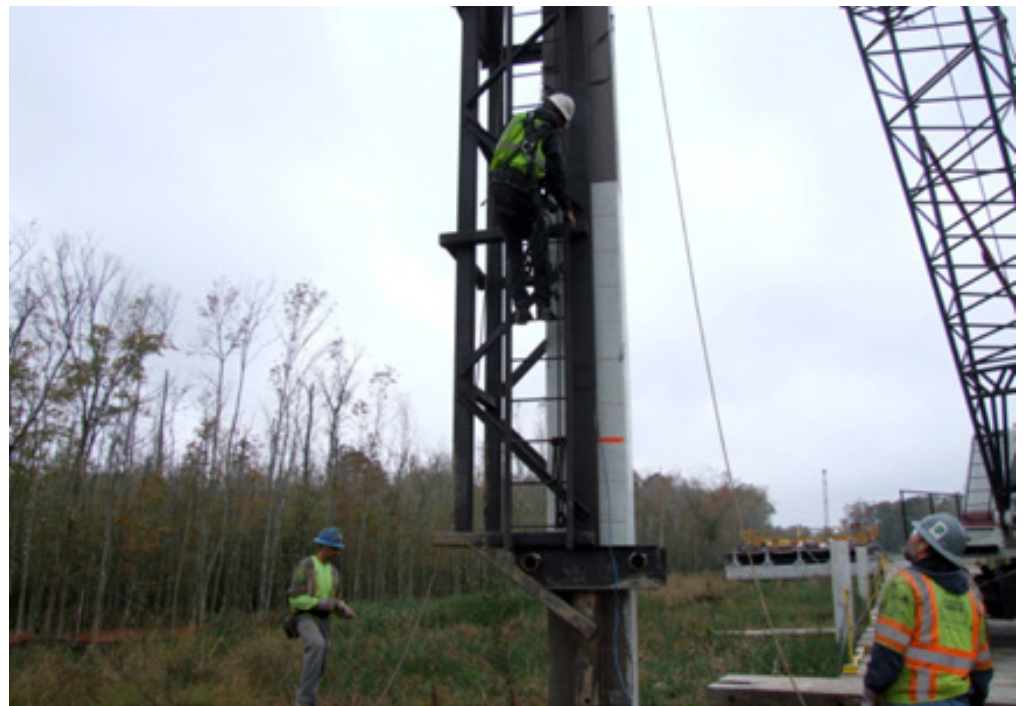
Fig. 1. Prestressed pile with Corrosion-Free Carbon Fiber Composite (CFCC) reinforcement being driven at the Nimmo Parkway Bridge site in Virginia Beach

Initially two test piles with CFCC were cast and driven (see Figure 1) to determine the length for the production piles. These concrete test piles were instrumented to determine the behavior during driving. The data indicated that during driving the behavior between the CFCC and the conventional piles was similar. After the successful completion of

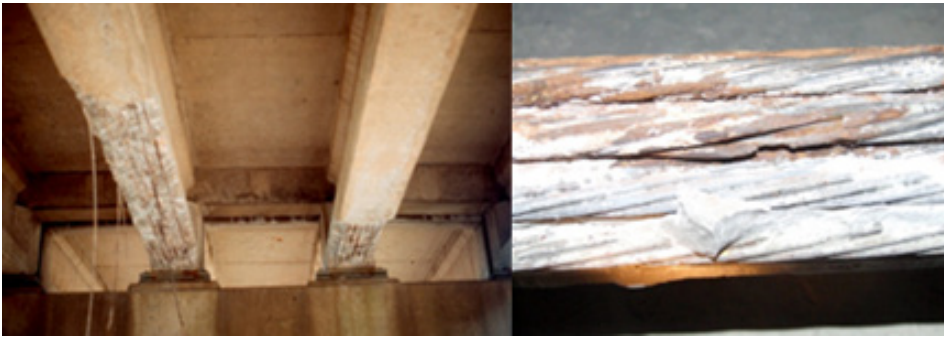
Fig. 2. Strands corroding in beams caused by leaking joints.

The corrosion of steel reinforcement in concrete structures is a common problem for state departments of transportation (DOTs) due to exposure to the marine environment or deicing salts (see Figures 2 and 3). The Virginia Department of Transportation (VDOT) has been using corrosion resistant reinforcement, such as solid stainless steel reinforcing bars (rebar), in bridge structures to extend their life by mitigating corrosion and thereby reducing concerns associated with maintenance costs, traffic congestion, and public safety. As a continuation of such efforts, VDOT has initiated research into improving prestressing strand materials. Corrosion is of great concern in strands, which are under high stress and used in load-carrying structural elements.

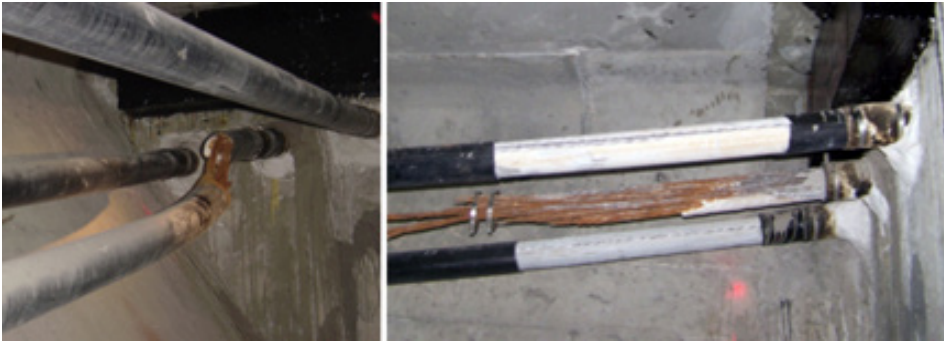
Fig. 3. Tendon failure in the Varina Enon Bridge because of strand corrosion.

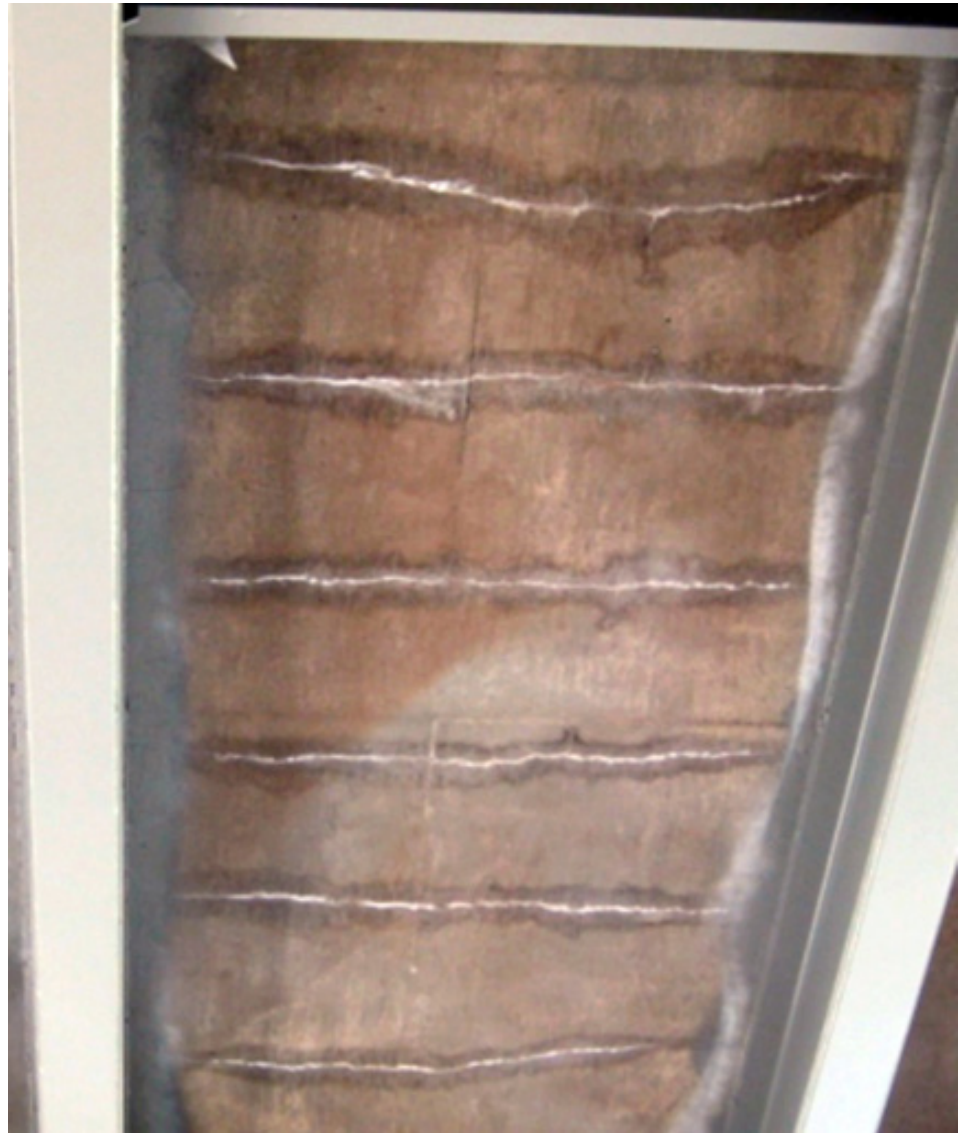
Fig. 2. Full depth leaking transverse cracks in concrete placed in a deck on I81 near Marion in 2009.

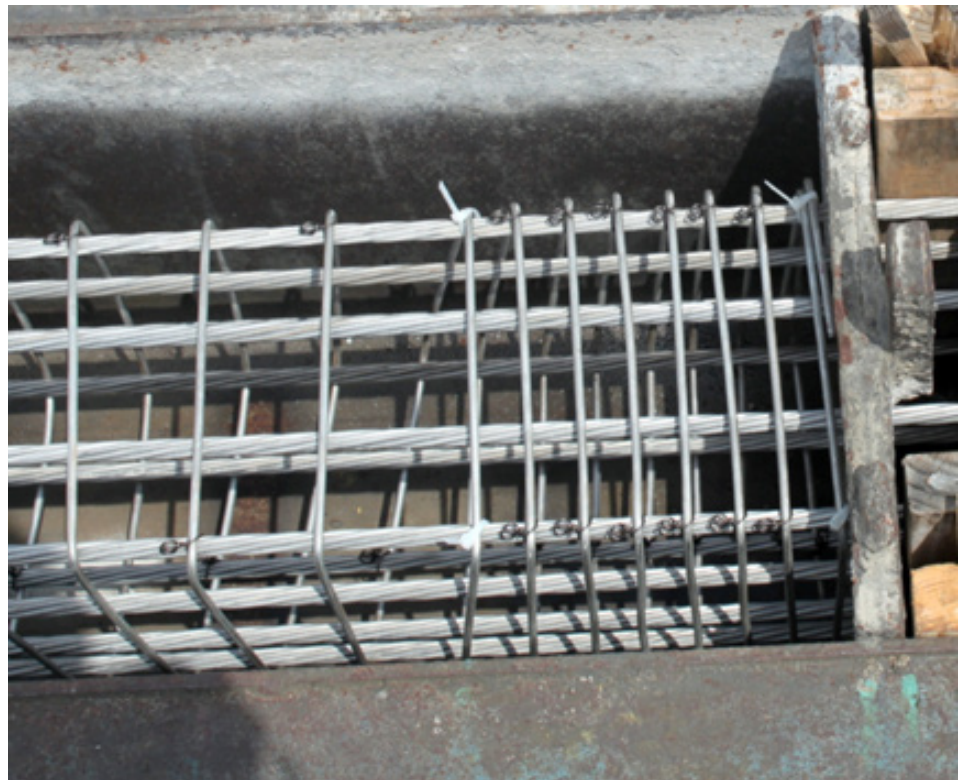
Fig. 1. 16-in. square pile with stainless steel grade 2205, 1/2-in. diameter 7-wire strands and with grade 304 stainless steel wire spiral.

Based on the superior strength and corrosion resistance of the 2205 alloy, 1/2-in. diameter strand was produced and was used to construct three 70-ft long, 16-in. square precast prestressed concrete piles. The strand was stressed to 70% of its 250 ksi ultimate strength. The stressing and construction operations were performed at Standard Concrete Products Company, Savannah, Georgia and proceeded identically to those for two companion piles made with conventional grade 1080 strand. Construction using 2205 stainless steel strands and grade 304 stainless steel wire spirals was completed with no difficulties and with no need for any special operations. Grade 304 with yield stress of 50 ksi was used for the spirals so that the small radius bends could be made; the high-strength 2205 wire could not be bent without fracturing. The

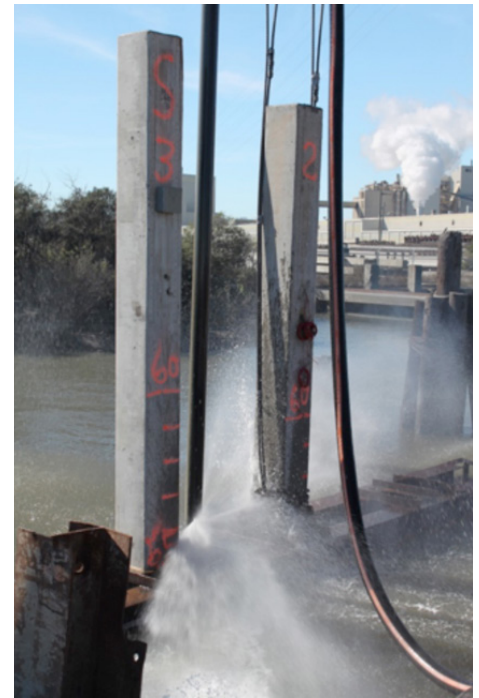
Fig. 2. 16-in., 70-ft long piles with stainless steel reinforcement being extracted after driving to refusal in Savannah River.

About six months following pile construction, three of the stainless steel reinforced piles and two piles with conventional strands were driven to refusal in the Savannah River. They were then extracted for future flexural, shear, and development length tests. No cracking, spalling or other damage was noted in any pile.

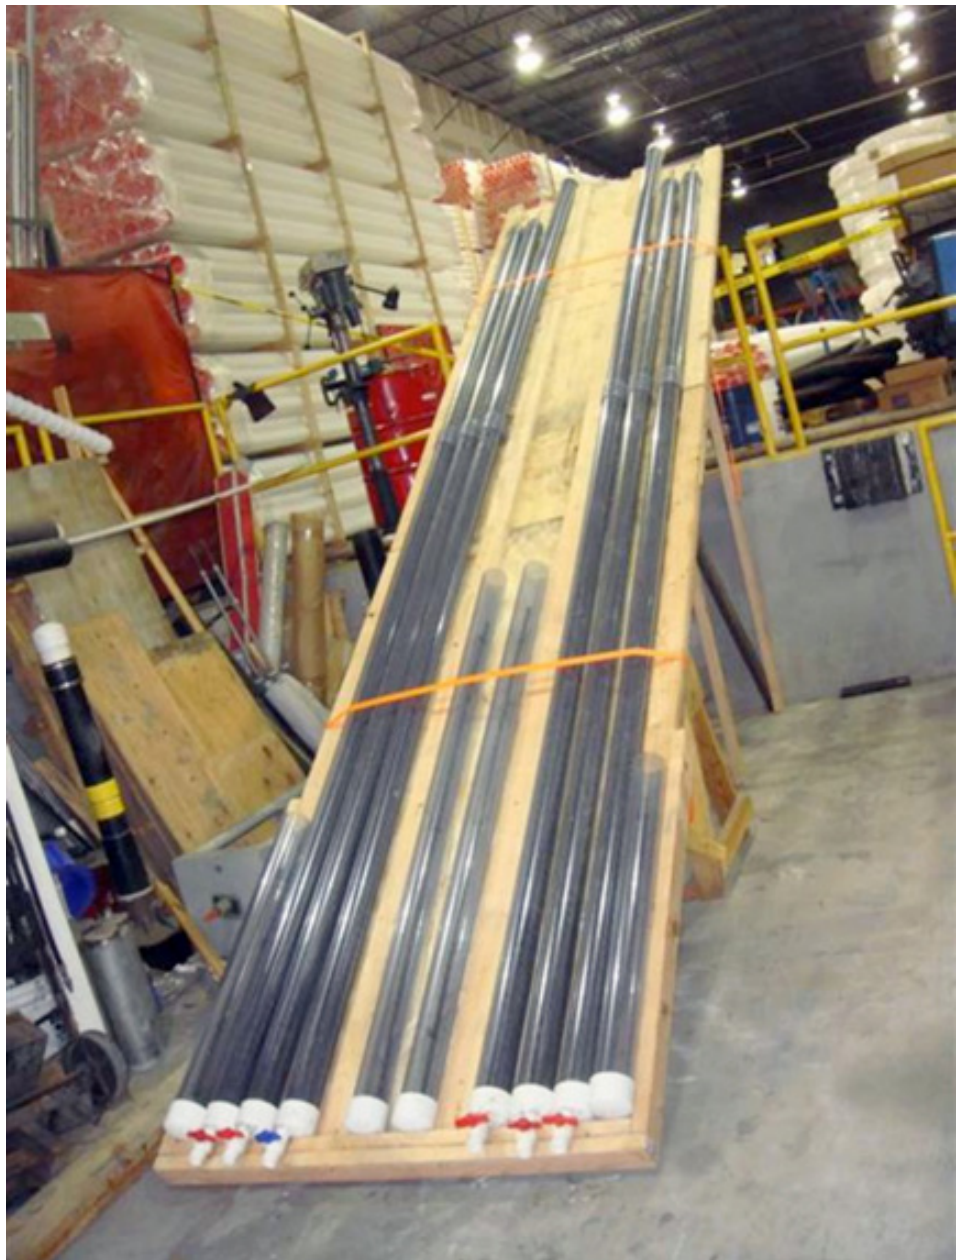
Fig. 1. The inclined tube test is a large scale bleed test. Photo: Structural/VSL

- segregation. Cements with a too high value require more water and admixtures to wet the surface, and tend to have earlier setting times.
- The bleed testing is enhanced with the introduction of the inclined tube test that is much more realistic reflection of a draped tendon in the structure, with its length of 16 ft at an angle of 30 degrees and with 12 strands in each sample (Fig. 1).
  - The wick induced test has also been revised to be more representative of actual conditions in a tendon by increasing the length of the test specimen using a 40-in.-long tube instead of the old short graduated cylinder.

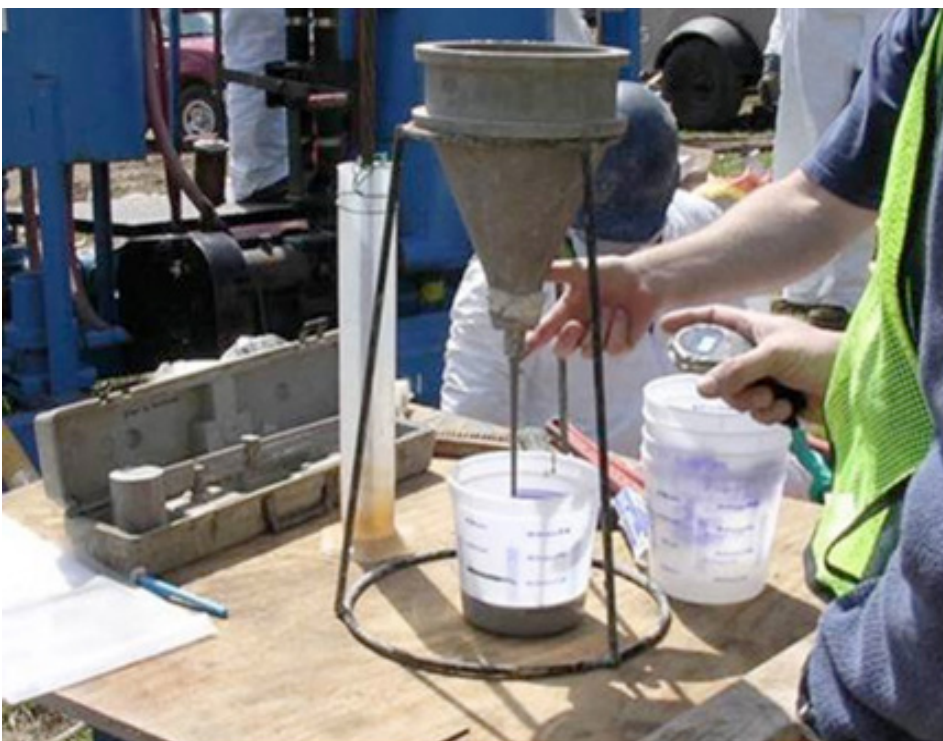
Fig. 2. The wet density and flowability are tested at mixer as well as at the the outlet

- The range of the constituent materials is now also given for the Class C (prepackaged grouts); in the previous edition, this was only given for the Classes A and B (the basic and engineered site-mixed grouts).
- The grouting operations and production testing were adjusted as well; the wet density and flowability are now measured at the mixer as well as at the outlet so that the grout quality and consistency within the tendon can be monitored (Fig. 2). The flushing of tendons is no longer permitted. Prewetting of ducts inadvertently adds water to the mix and flushing in cases of grout problems creates a situation that is very difficult to repair. Finally, low grouting pressures and no pressurization of the tendons after grouting are recommended.
