Bridge Views

Issue 78 _____ September/October 2014

Dimensional stability of cementitious grouts in prefabricated bridge connections – Ensuring good performance

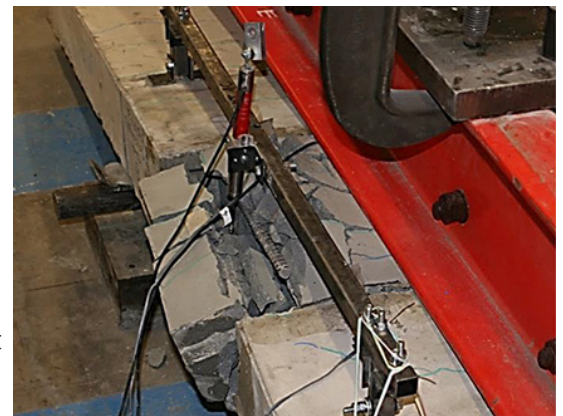
Fig. 1. Reinforcing bar-to-grout bond failure during fatigue loading in lab experiments carried out at Federal Highway Administration's Turner Fairbanks Research Center.

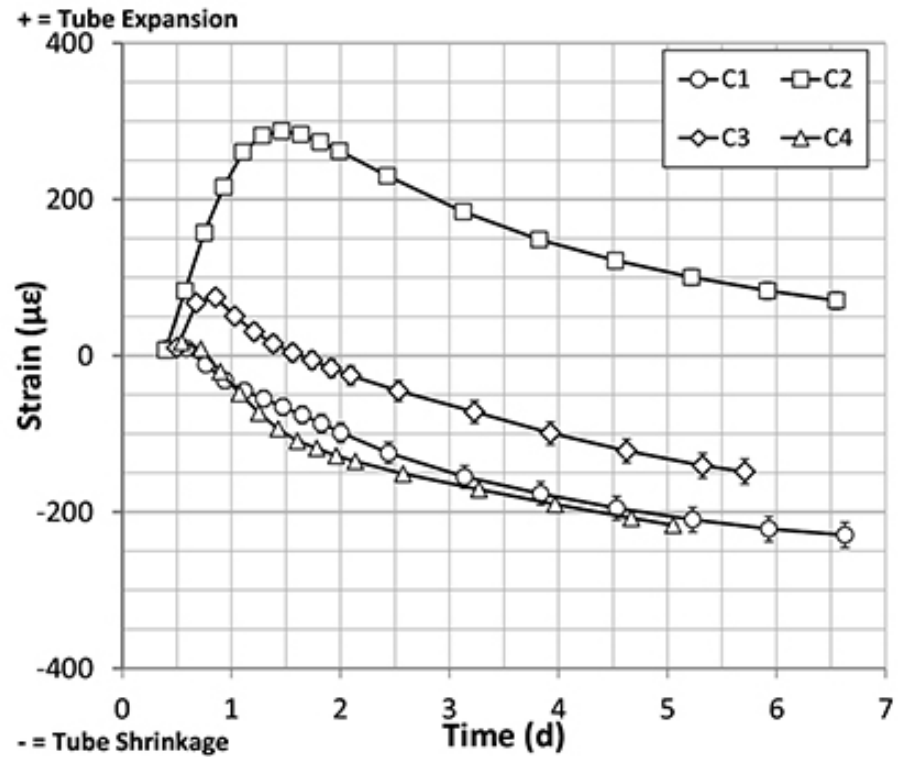
Fig. 2. Dimensional stability test results: (a) Autogenous (sealed) deformations measured from time of set via ASTM C1698, and (b) long-term deformations in both sealed and drying conditions measured from the age of 1 d via ASTM C157

conditions. This was done using both ASTM C1698² (Figure 2-a) and ASTM C157³ the latter for long-term results (Figure 2-b). The curing condition of field-cast grout materials is important because some PBES connections will be completely sealed, while others will be partially exposed to the environment (drying).

As observed in Figure 2-a, and despite being designed as “non-shrink”, the grouts show autogenous shrinkage at some point, either preceded by a flat region (C1, C4) or by an initial expansion (C2, C3) during the first hours. Long-term shrinkage results (Figure 2-b) show a considerable amount of autogenous shrinkage (about 500-600 $\mu\epsilon$) for C1, C3, and C4. The large expansion observed in C2 in Figure 2-a helps in reducing most of its final shrinkage (about 200 $\mu\epsilon$). However, it has been stated that it is the rate of shrinkage (i.e., the slope of the autogenous shrinkage response) what makes the material more prone to shrinkage cracking, rather than the total shrinkage. Drying shrinkage is at least 1000 $\mu\epsilon$ greater than sealed shrinkage in all cases, due to the drying effect of the capillary pores.

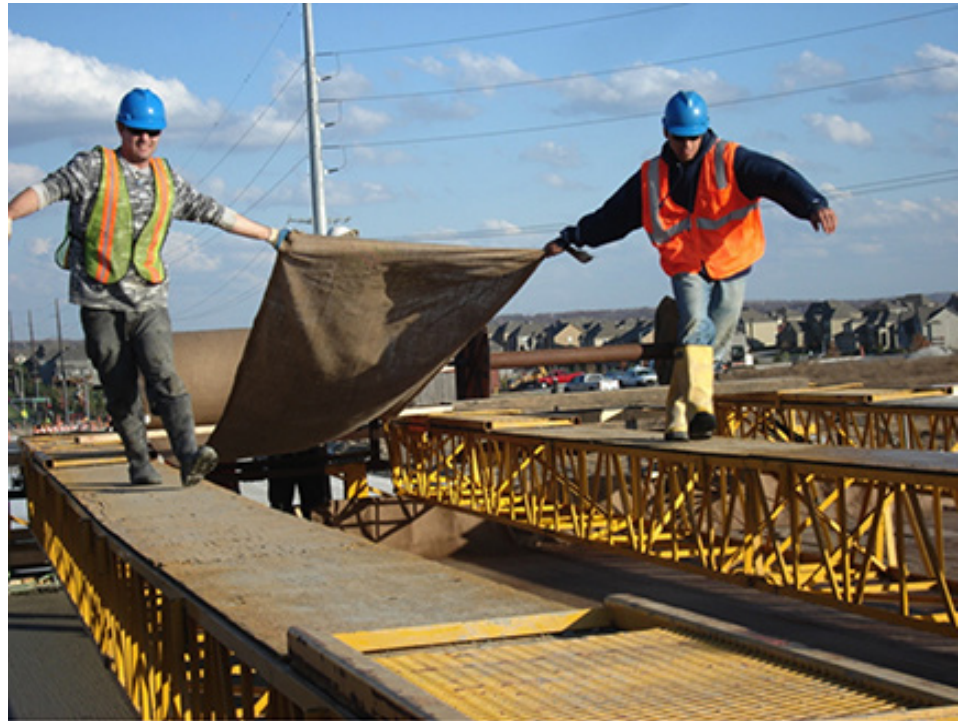
Fig. 1. Pre-cut, rolled, wet burlap is placed within 10 minutes of strike-off.

After concrete placement, fully saturated, presoaked burlap is placed within 10 minutes of strike-off (see in Figure 1) and kept constantly wet with spray hoses until the concrete has set. Soaker hoses are then placed and the burlap is covered with white plastic. Curing continues for 14 days. To allow the concrete to dry slowly, the deck is sprayed with a curing compound upon removal of the burlap. The curing compound is maintained for seven days. The deck forms are removed within two weeks of termination of curing so that the deck can dry from both sides. The
